# VEHICLE INSPECTION REPORT

**DG680FN**

## Mercedes-Benz Sprinter 314 CDI

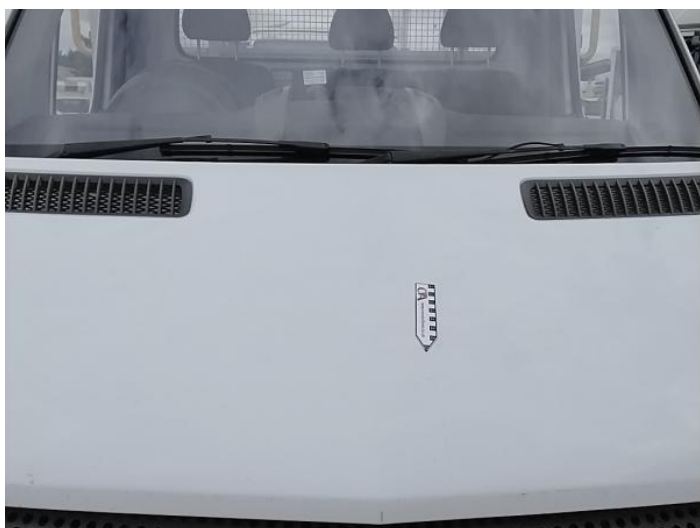
1: Bonnet  
Scratched  
UpTo 25mm Thru Paint

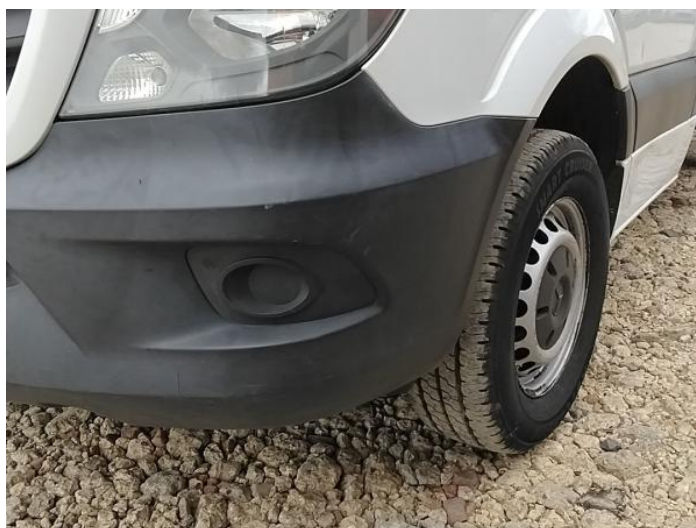
2: Bumper Front Moulding  
Scuffed (Unpainted)  
UpTo 100mm
